## RESEARCH LETTER

### Changes to Polymer Surface of Drug-Eluting Stents During Balloon Expansion

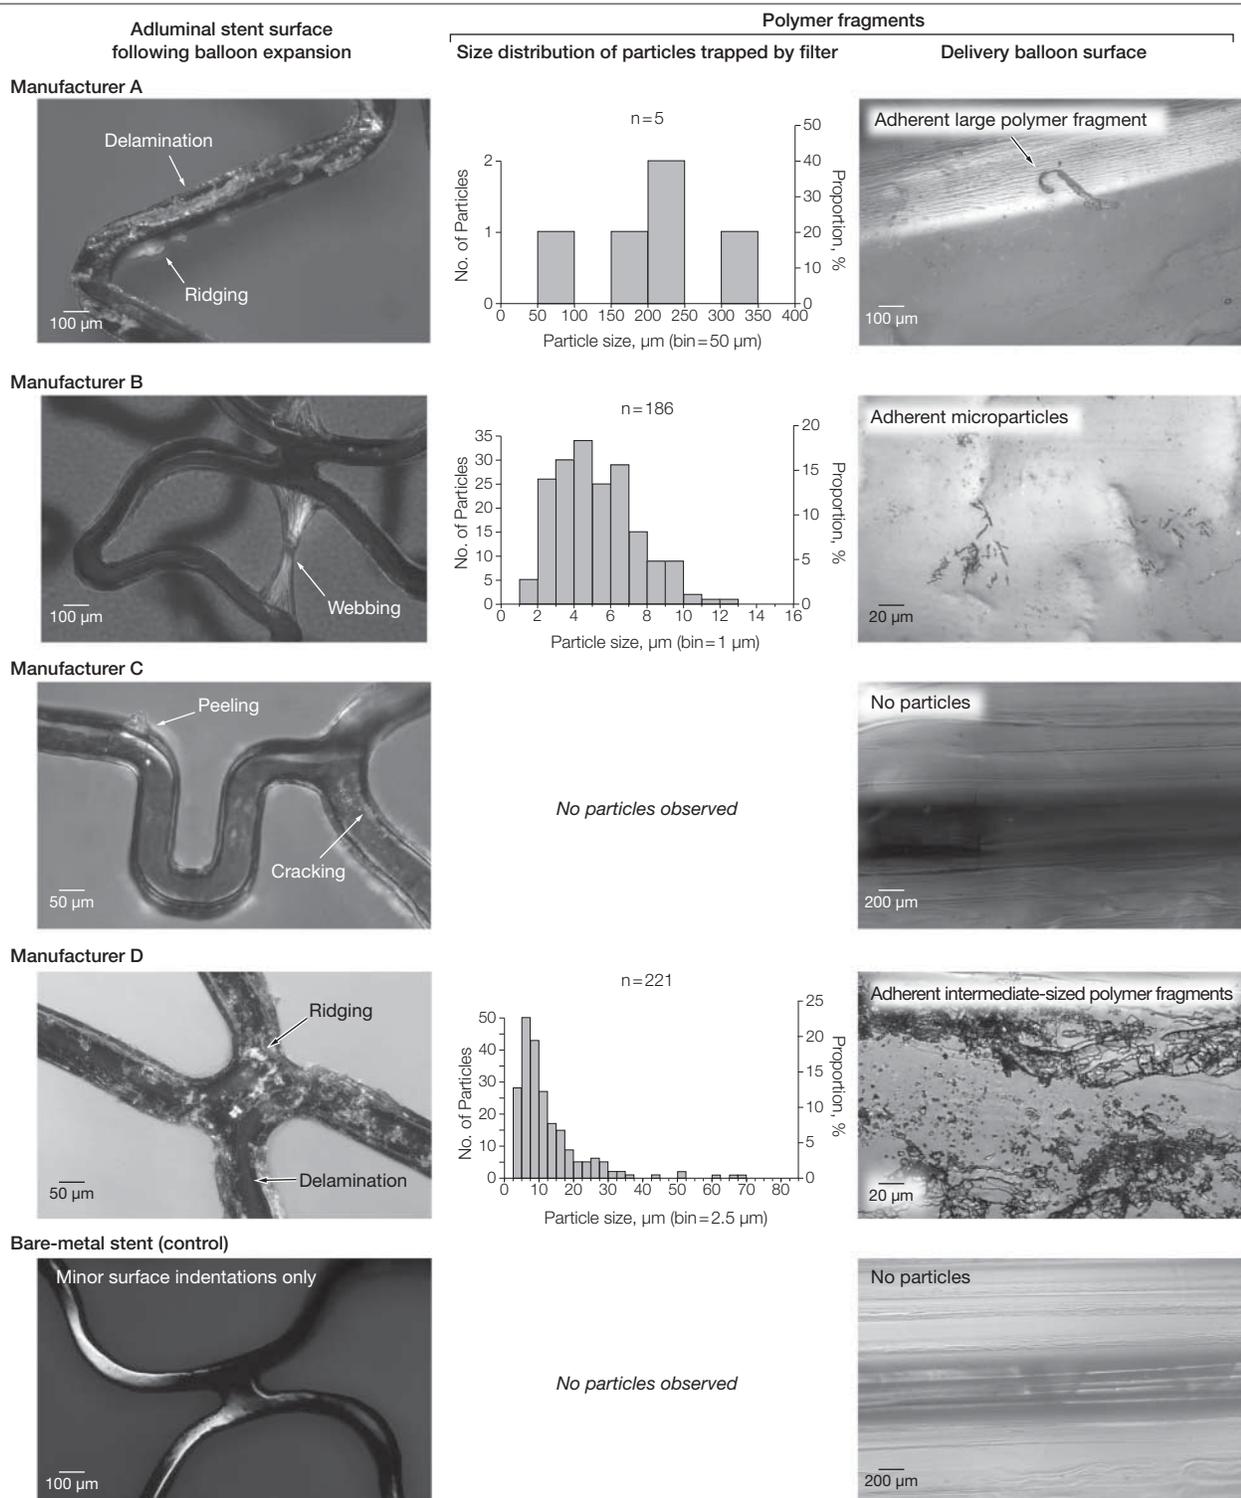
**Figure.** Representative Damage to the Polymers on the Adluminal Surface of Each Drug-Eluting Stent Following Balloon Expansion

Each stent shown was 3.0 mm in diameter and 16 to 18 mm in length. The adluminal and abluminal polymer surface of the drug-eluting stents were systematically imaged following balloon expansion using optical microscopy (Olympus BX 60; Olympus America Inc). Magnification was 50 to 500 $\times$ . Each polymer surface was imaged at 16 locations (8 adluminal, 8 abluminal), spanning the length of the drug-eluting stents. The locations were predefined in a spiral configuration. For quantitative measurements, the magnification was 100 $\times$ . Values in each bin interval are greater than the lower limit of the interval and less than or equal to the upper limit.

**Results.** Prior to balloon expansion, the abluminal polymer surface of DES D showed cracks; abluminal surfaces of all other DES appeared homogeneous. Following balloon expansion, the abluminal and adluminal polymer surfaces of all DES were damaged, affecting 4.6% to 100% of the surface area imaged (FIGURE and TABLE). In the Figure, the proportion of the surface area affected by each form of damage relative to the total surface area imaged was determined using quantitative image analysis. For webbing, the area of the 2 bases forming each individual web was used for the calculation.

No significant differences were observed between various expansion conditions for each particular DES; therefore results were pooled across conditions. Surface damage ranged from deformation (ridging, cracking, peeling, or webbing) to complete delamination with visually confirmed separation of polymer. The dimensions of damage and of detached microparticles ranged from 2 to 350  $\mu\text{m}$ . Microparticles from all but DES B were confirmed to be polymer. The extent of damage differed by manufacturer (*P* < .001 for adluminal and *P* = .002 for abluminal damage).
